BEST PROPERTY INSPECTIONS

Invoice

Subject Property:
5768 SOMEWHERE CT.
SAN DIEGO, CA. 92101

Invoice Date: Feb 15, 2012
Inspection Date: Feb 15, 2012
Invoice #: 4097
Report #: 6019
Inspector : SEAN M. BLASIUS

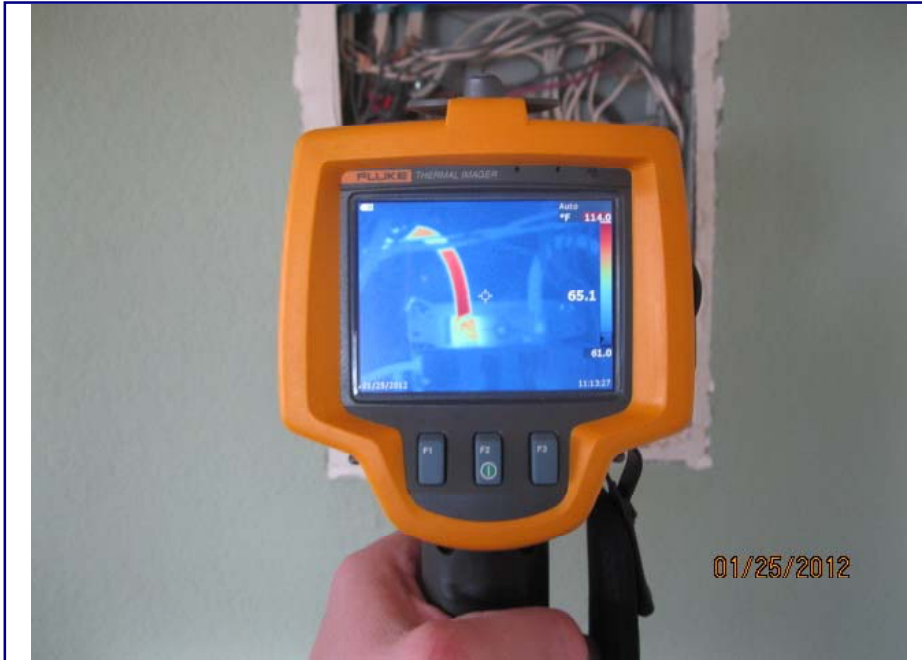
Picture 1

A HIGH-RESISTANCE CONNECTION OR COMPONENT MALFUNCTION NOTED AT LEFT SIDE OF SUB PANEL ELECTRIC SERVICE ENTRANCE CABLE. 110 DEGREES FAHRENHEIT NOTED AT LEFT CABLE, 65 DEGREES NOTED AT RIGHT CABLE.(2,4)

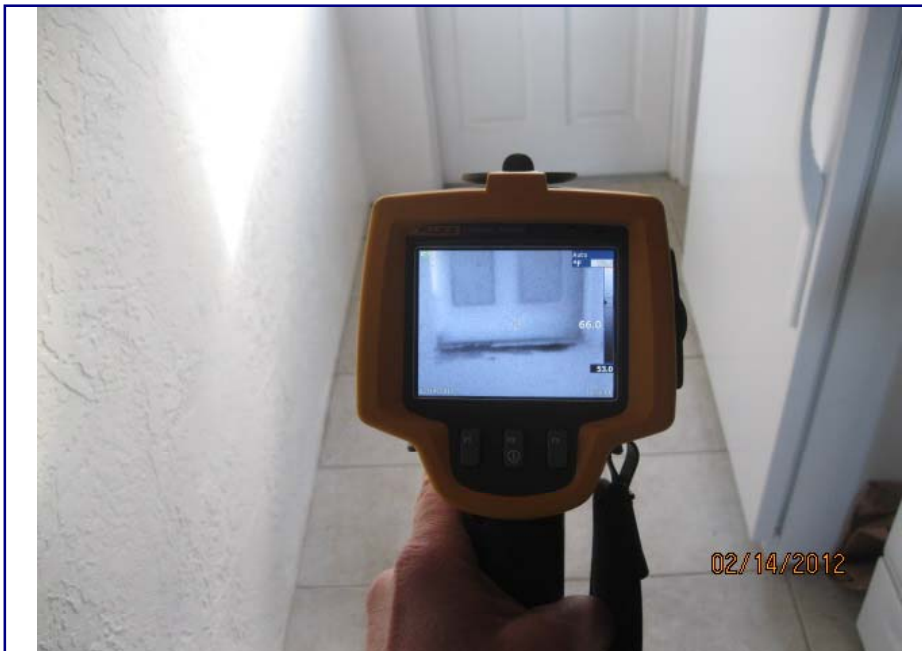
Picture 2

DARK THERMAL PATTERN AT BASE OF DOOR SHOWS MOISTURE INTRUSION AT THIS INTERIOR DOOR THRESHOLD AND FLOOR CONNECTION.(2,3)

IMPROPER FLASHING, OPENING NOTED AT DECK OPPOSITE SIDE, IT HAD JUST RAINED.*

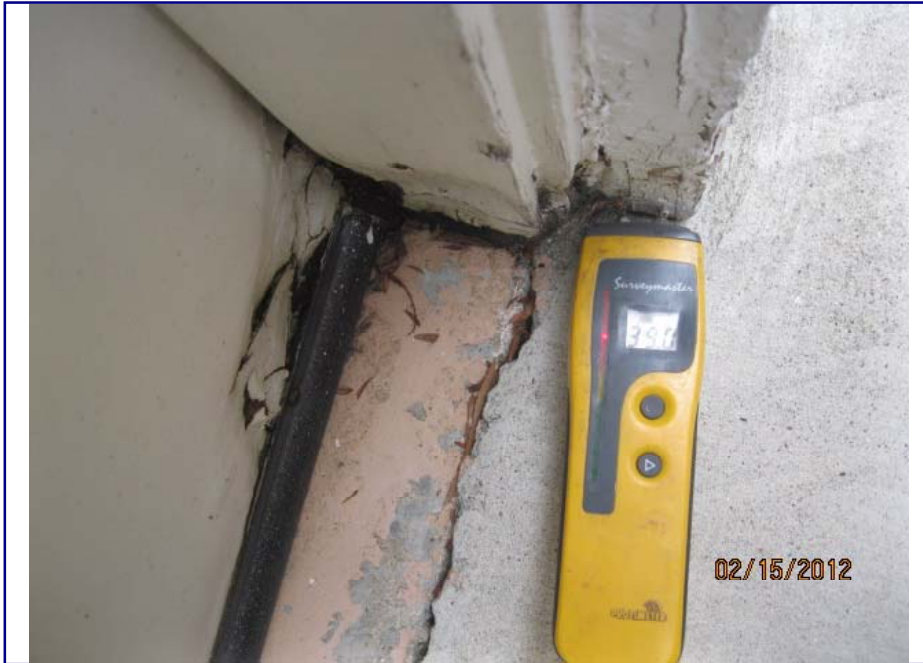
Picture 3

ACTIVE MOISTURE, DAMAGE, DETERIORATION WAS NOTED AT BASE OF DOOR AND FRAME, GARAGE PASSENGER DOOR WHEN TESTED WITH MOISTURE METER.(2,3)

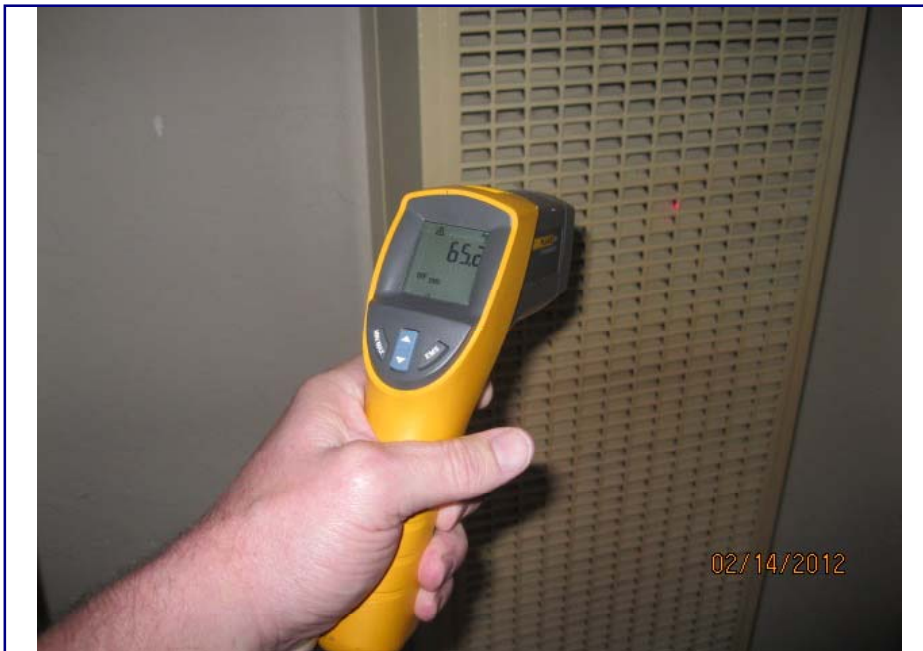
Picture 4

WALL FURNACE WAS NOT OPERATIONAL WHEN TESTED WITH IR THERMOMETER, ELECTRONIC IGNITION MALFUNCTION NOTED.(2)

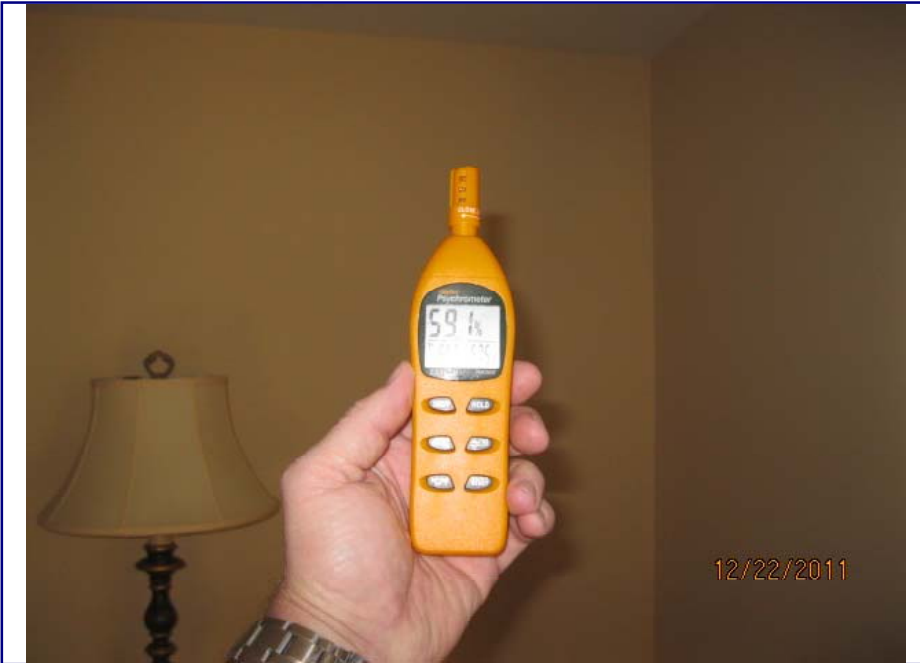
Picture 5

30% PRESENT DIFFERENTIAL IN HUMIDITY WAS NOTED WHEN WHEN TESTED WITH PSYCHROMETER FROM UPSTAIRS TO DOWNSTAIRS. A BUILT IN DEHUMIDIFIER WAS NOTED, BUT IS NOT PART OF A HOME INSPECTION THEREFORE WAS NOT TESTED OR INSPECTED.*

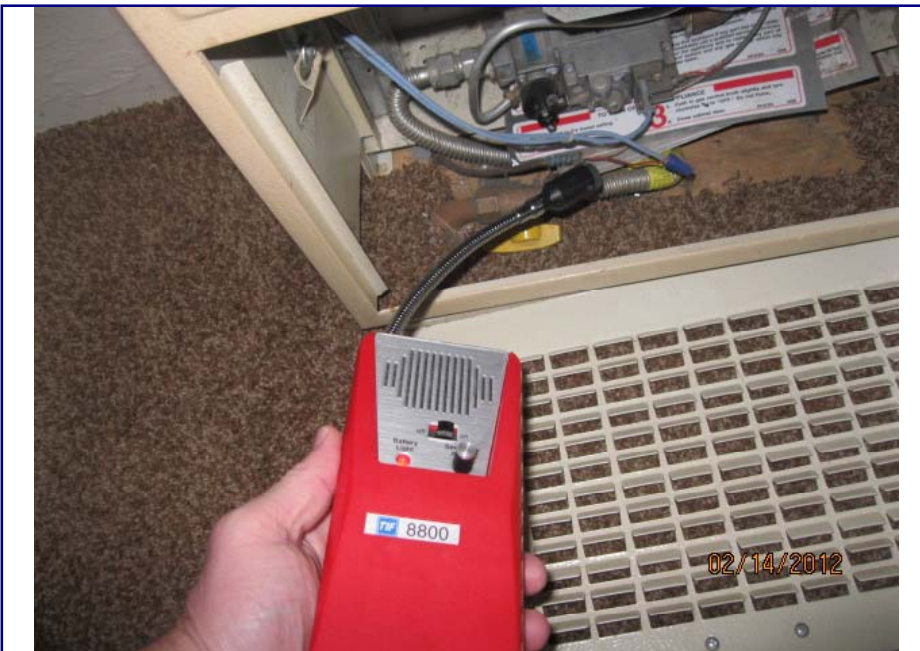
Picture 6

NATURAL GAS LEAK WAS NOTED AND VERIFIED WHEN TESTED WITH GAS DETECTOR AT LOWER HALL WALL HEATER.(2,4)

GAS LINE WAS TURNED OFF CONTACT 800-411-SDGE

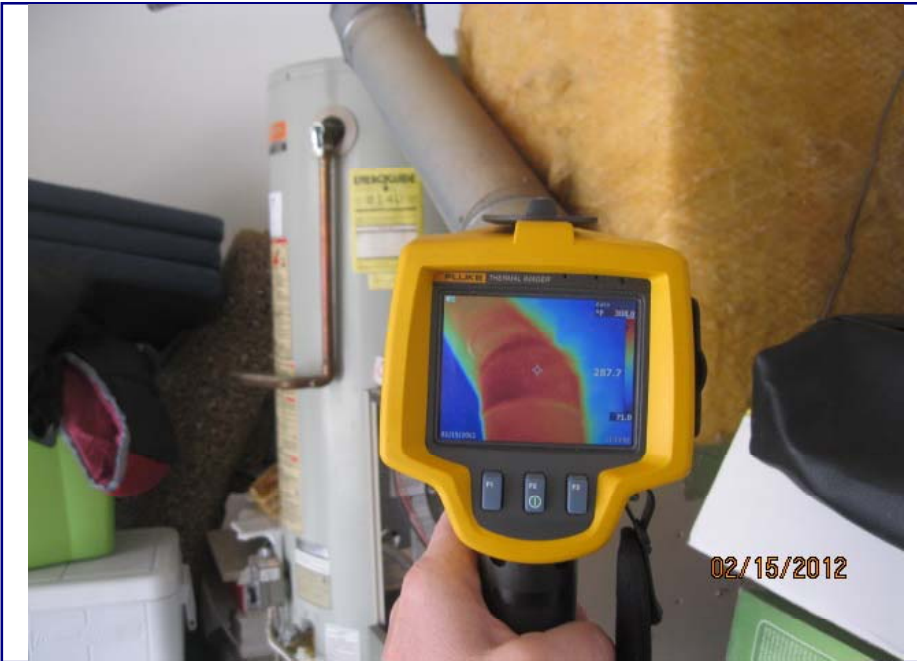
Picture 7

FORCED AIR FURNACE VENT PIPE WAS TOUCHING INSULATION, CLEARANCE TO COMBUSTIBLES WAS IMPROPER.(2,4)

SEISMIC STRAPS WERE MISSING, NOT INSTALLED AT 50 GAL. HOT WATER HEATER.(2,4)

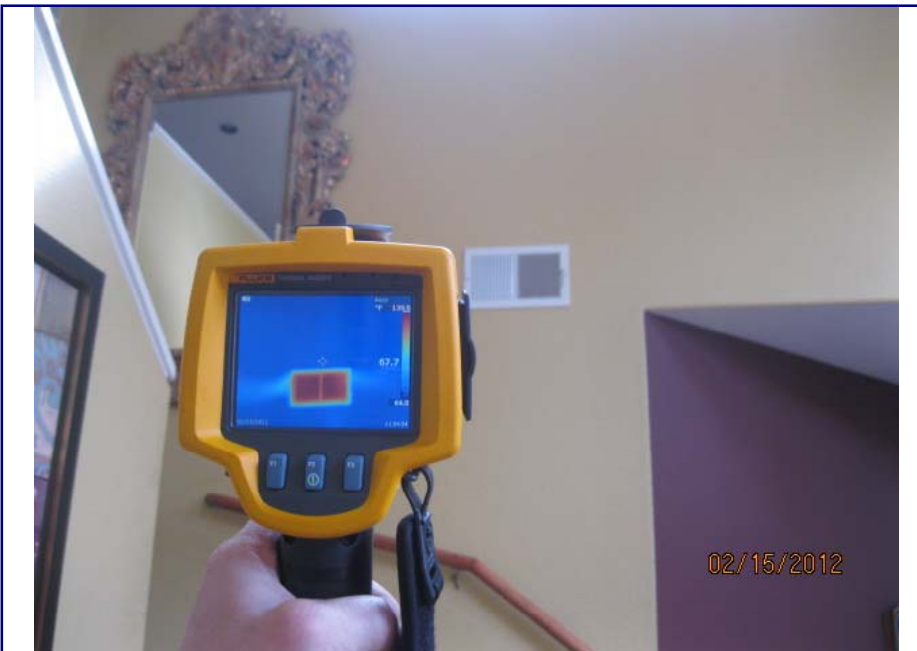
Picture 8

FORCED AIR FURNACE WAS OPERATIONAL WHEN TESTED, ALL INTERIOR REGISTERS WERE CONNECTED. NO A/C WAS INSTALLED AND HOUSE WAS NOT PLUMBED FOR IT.*

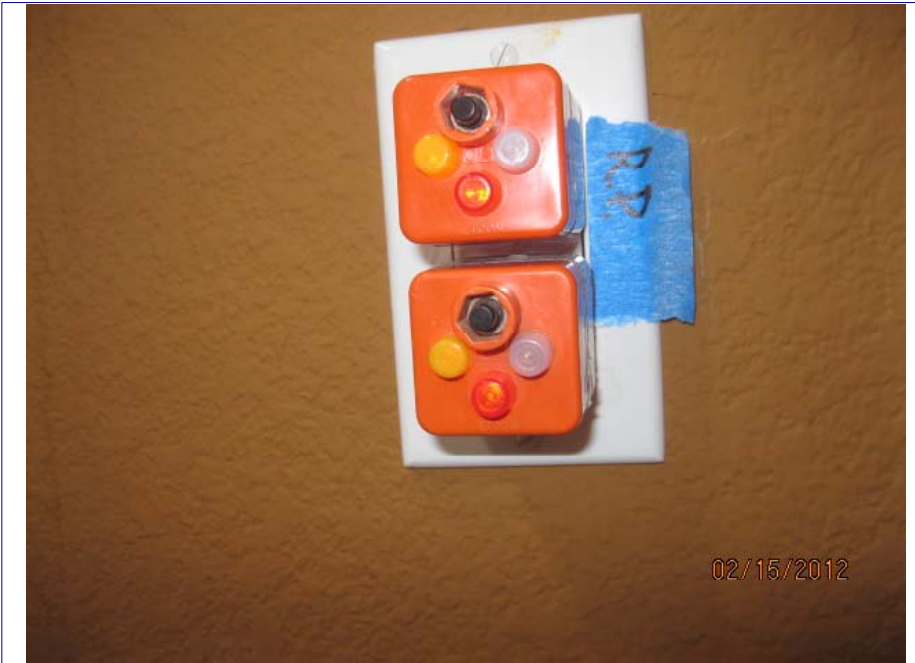
Picture 9

REVERSE POLARITY WAS NOTED AT THIS MASTER BEDROOM PLUGGED RECEPTACLE WHEN TESTED WITH CIRCUIT TESTERS. LABELED WITH BLUE TAPE.(2,4)

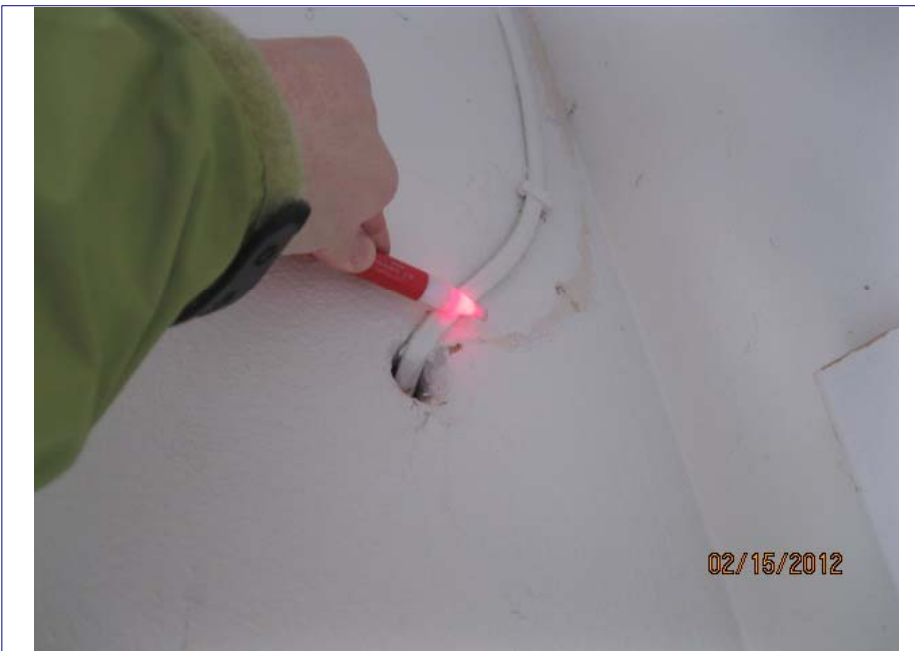
Picture 10

IMPROPER EXPOSED WIRING WAS NOTED AT GARAGE THIS LOCATION LIVE EXPOSED ELECTRICAL WIRE (ROMEX) NOTED VARIOUS AREAS. A CONDUIT (EMT) ELECTRICAL METAL TUBING IS NEEDED.(2,4) PLASTIC WIRE MOLD WAS USED AND WAS NOT CONTINUOUS, OPENINGS NOTED. ALSO WIRE MOLD MAY NOT BE USED TO EXTEND HARD WIRED (PERMANENT) ELECTRICAL WIRING. MUST USE LISTED FITTINGS AND JUNCTION BOXES (2 4)

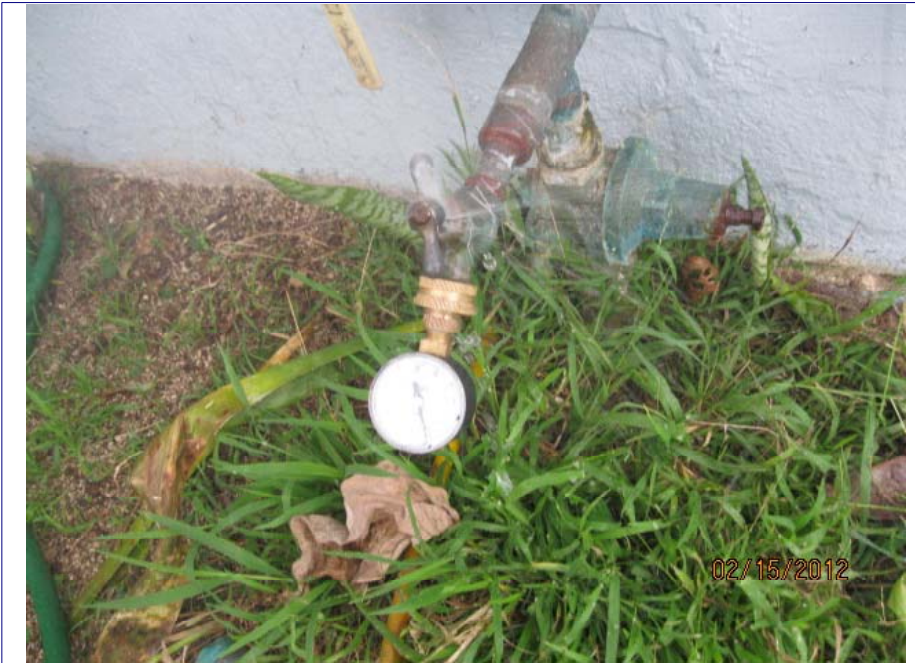
Picture 11

WATER PRESSURE WAS ON THE HIGH SIDE 82 PSI NOTED. (2) THE RANGE IS 40-80 PSI.*

HOSE FAUCET HANDLE LEAKED WHEN OPERATED AT VARIOUS AREAS.(2)

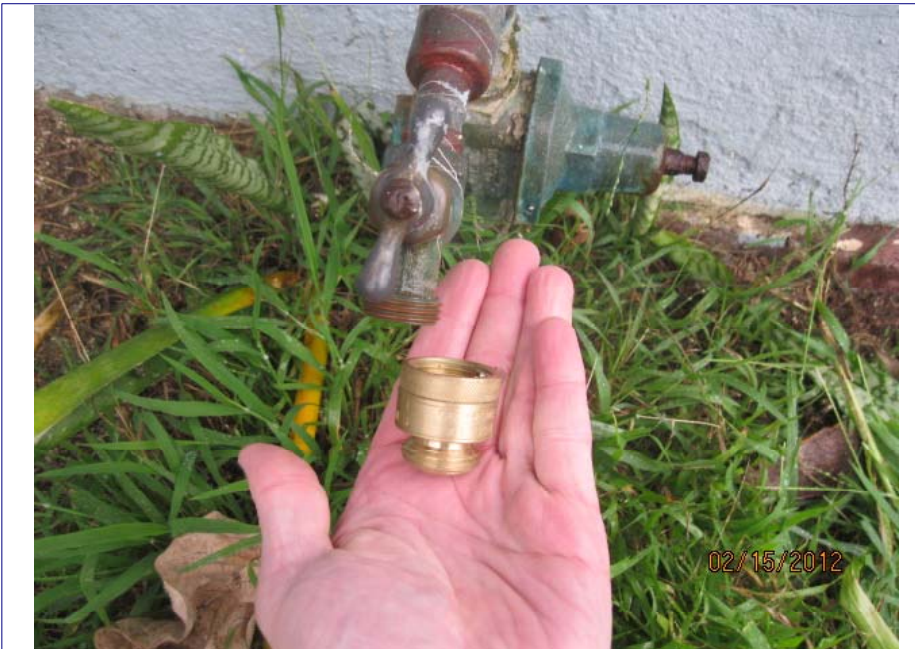
Picture 12

HOSE FAUCETS ARE NOT ANTI-SIPHON TYPE VALVE.(2)

RECOMMEND ADDING AS SHOWN.*

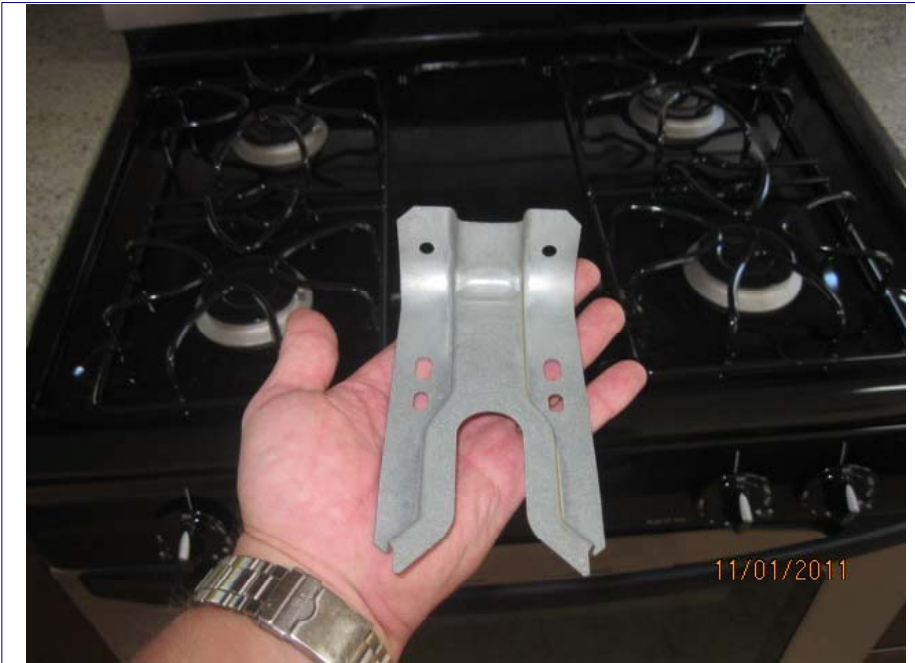
Picture 13

STOVE/OVEN WAS MISSING ANT-TIP BRACKET, NOT INSTALLED.(2,4,5)

RECOMMEND ADDING AS SHOWN.*

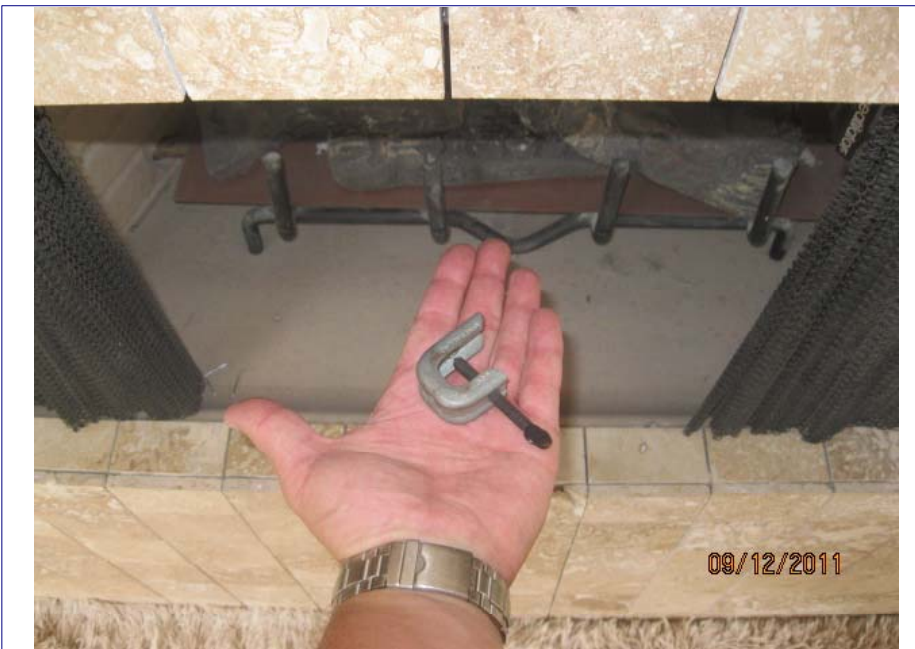
Picture 14

FIREPLACE HEARTH EXTENSION WAS MISSING AT DEN FIREPLACE, CARPET NOTED.(2,4,5)

DAMPER STOP (CLAMP) NEEDED AT FIREPLACE DAMPER GAS SYSTEM WAS INSTALLED.(2,4,5)

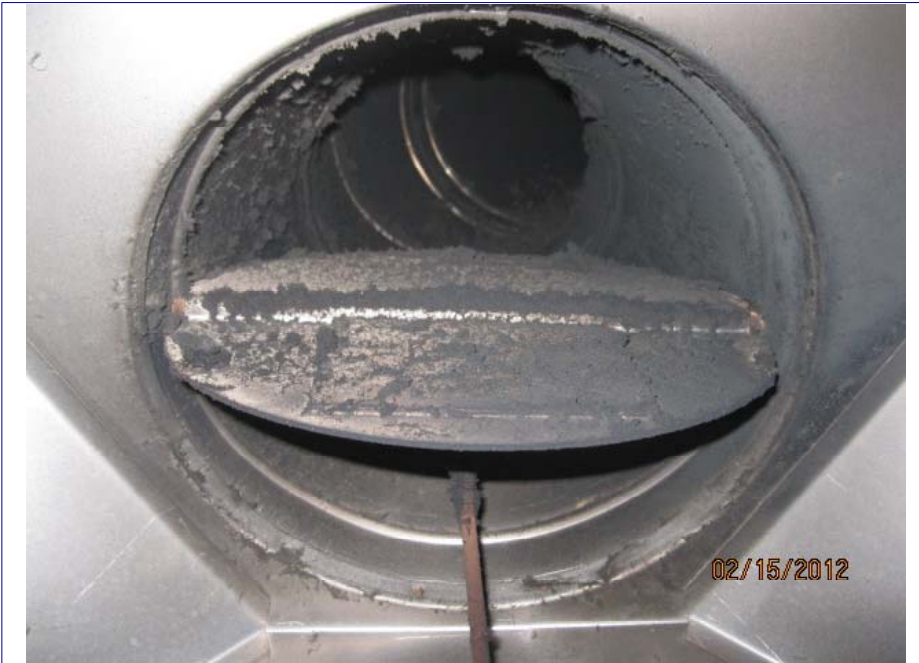
Picture 15

DAMPER STOP (CLAMP)
NEEDED AT FIREPLACE
DAMPER GAS SYSTEM WAS
INSTALLED.(2,4,5)

RECOMMEND ADDING AS
SHOWN.*

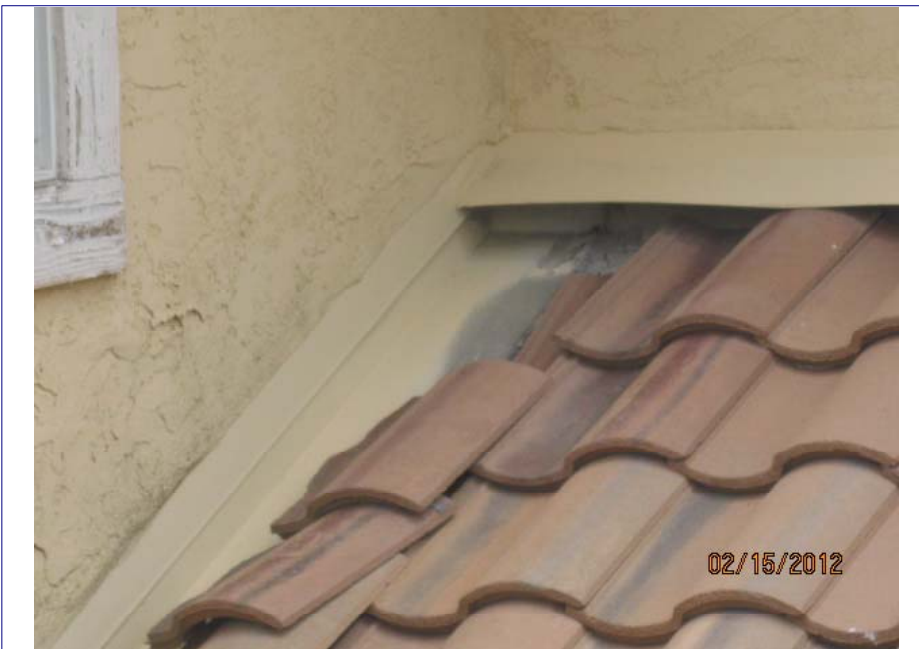
Picture 16

LOOSE CONCRETE ROOF
TILES NOTED AT ROOF AND
WALL CONNECTION THIS
AREA REAR YARD
NORTHEAST SIDE.(2)

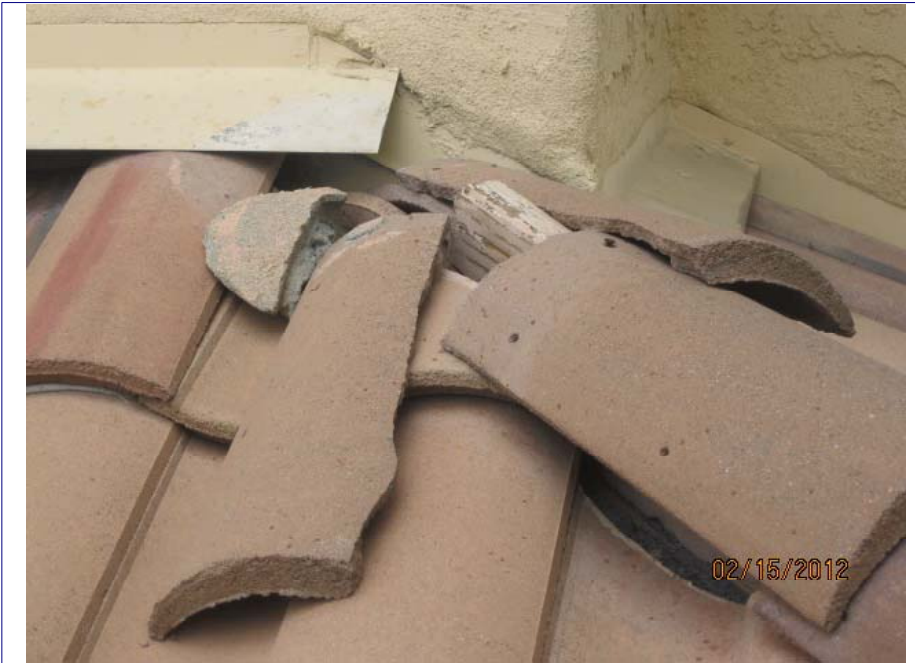
Picture 17

CRACKED, BROKEN
CONCRETE ROOF TILES
NOTED AT ROOF RIDGE
AREA ABOVE REAR PATIO.
EXPOSED WOOD,
CRACKED DAMAGED
MORTAR ALSO NOTED(2)

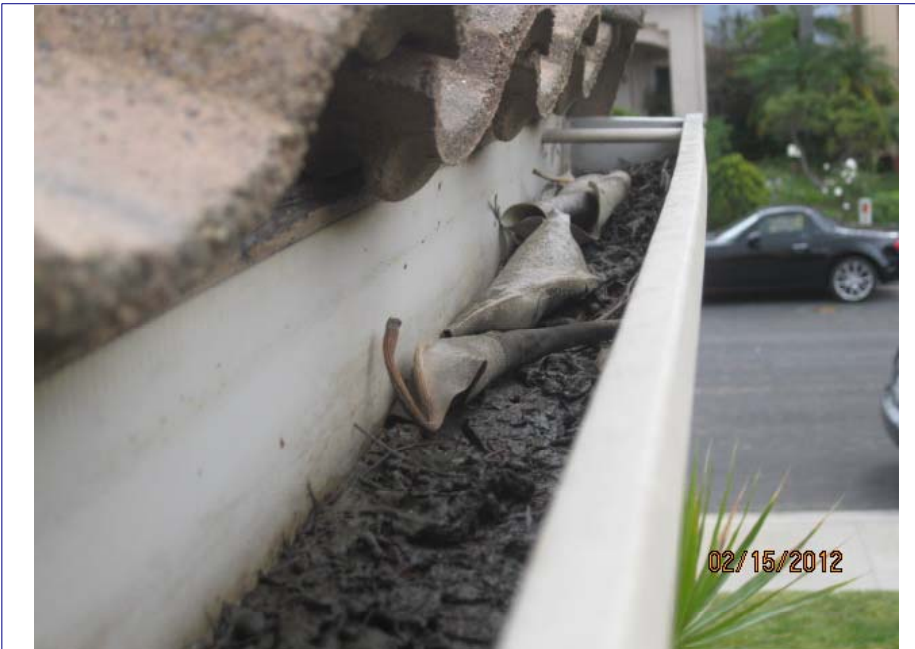
Picture 18

PARTIAL RAIN GUTTERS
WERE DEBRIS FILLED AT
VARIOUS AREAS.(2)

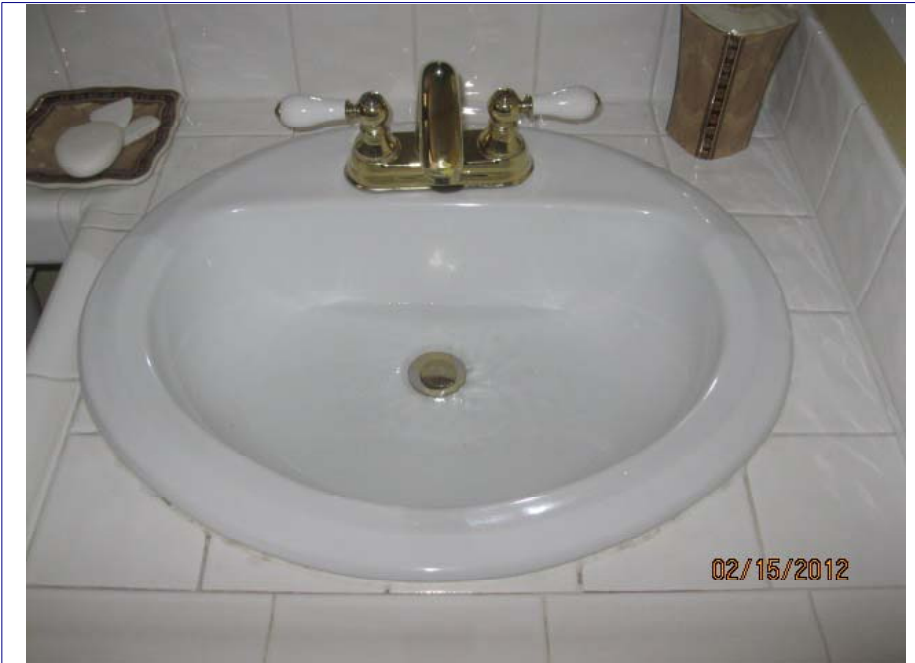
Picture 19

LOWER BATHROOM SINK WAS SLOW DRAINING WHEN TESTED.(2)

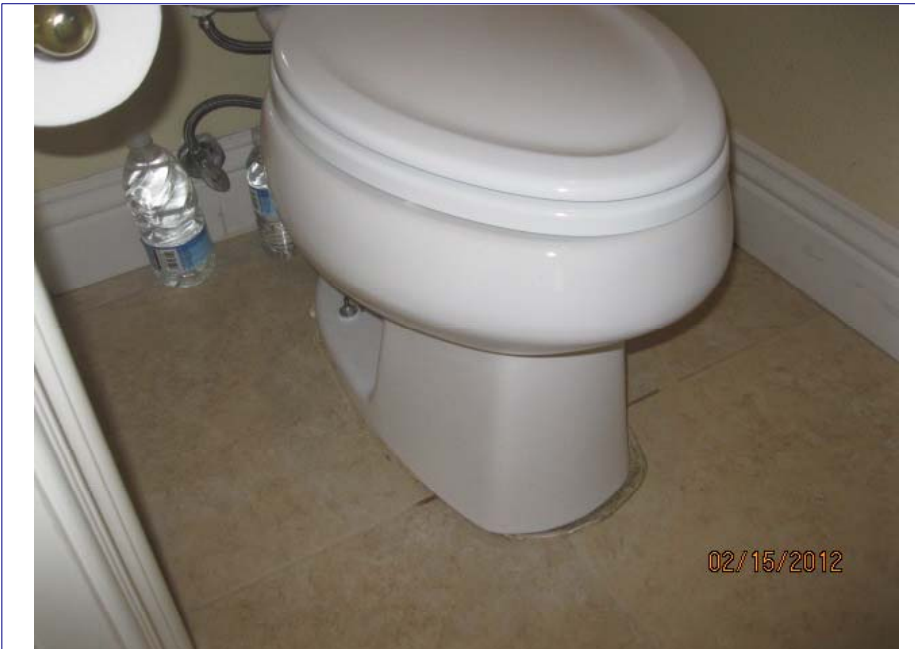
Picture 20

LOWER BEDROOM TOILET WAS LOOSE AT FLOOR, RECOMMEND NEW WAX SEAL. CHINA CAPS MISSING AT EXPOSED BOLTS.(2)

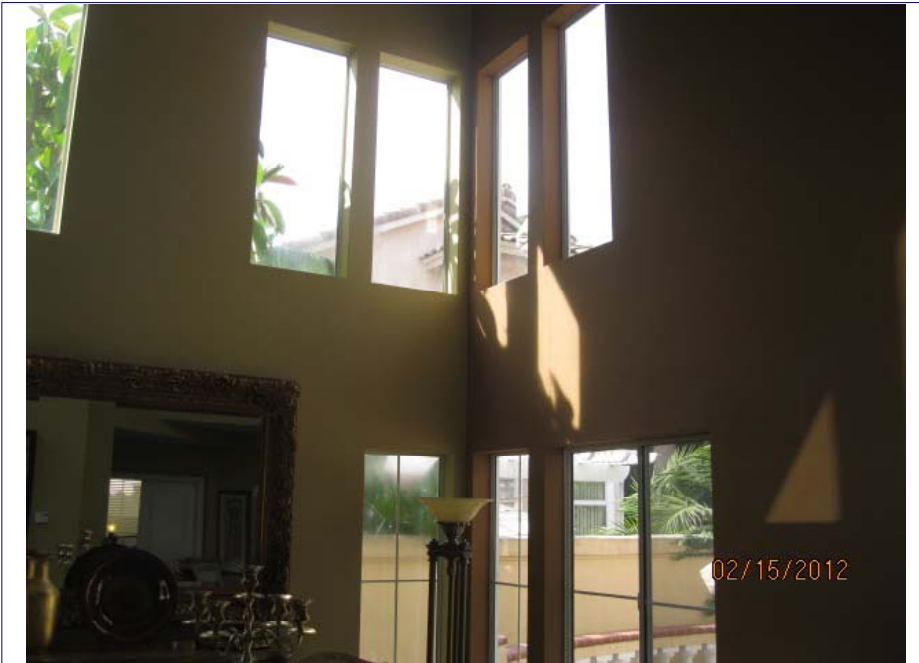
Picture 21

ALL ALUMINUM CASEMENT AND SLIDING WINDOWS IN PHOTO DUAL PANE FOGGED.(2)

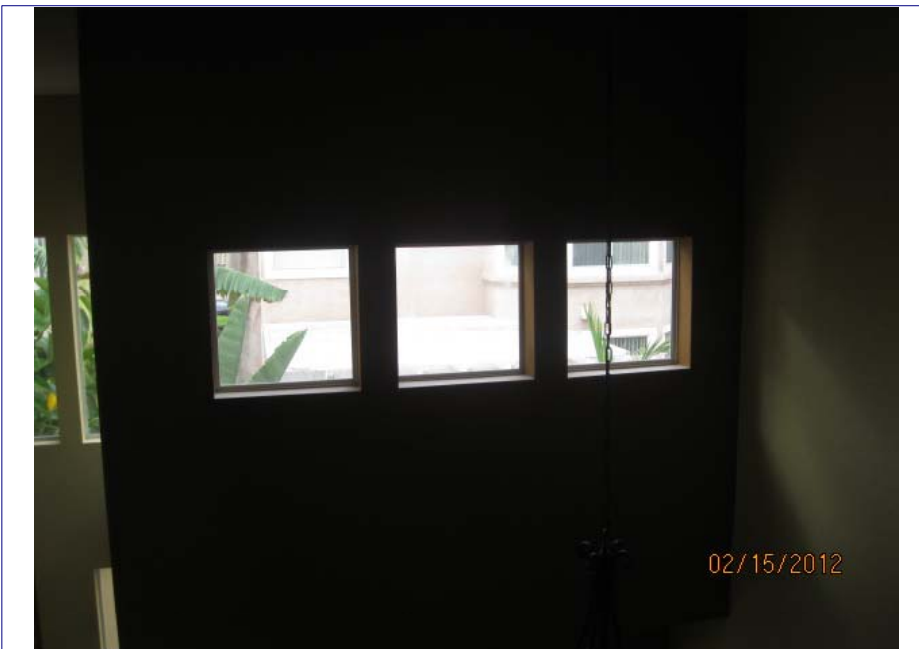
Picture 22

MIDDLE ALUMINUM CASEMENT WINDOW DUAL PANE FOGGED.(2)

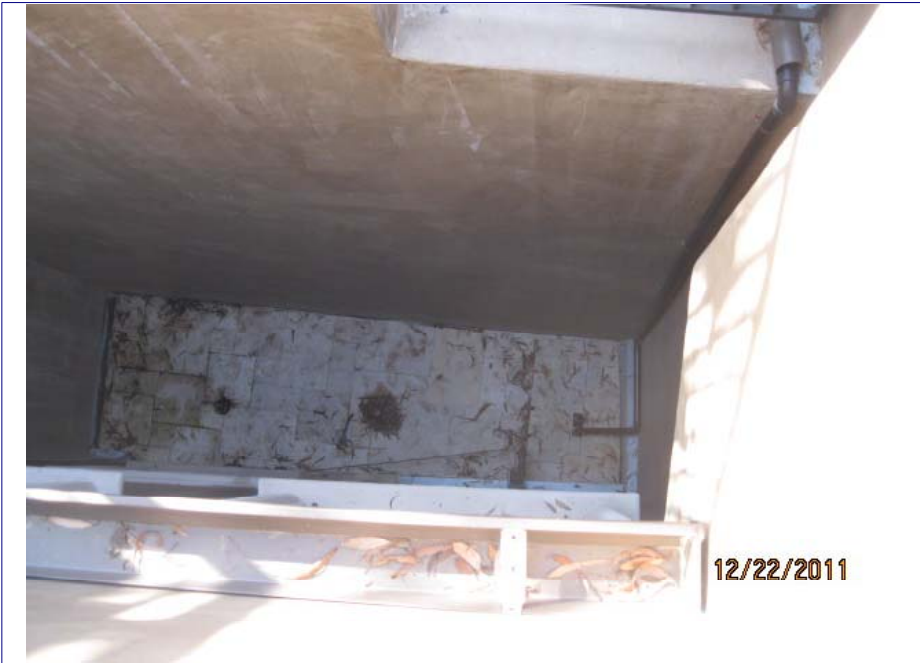
Picture 23

SUMP PUMP IS NOT PART OF A HOME INSPECTION, THEREFORE WAS NOT INSPECTED.(2)

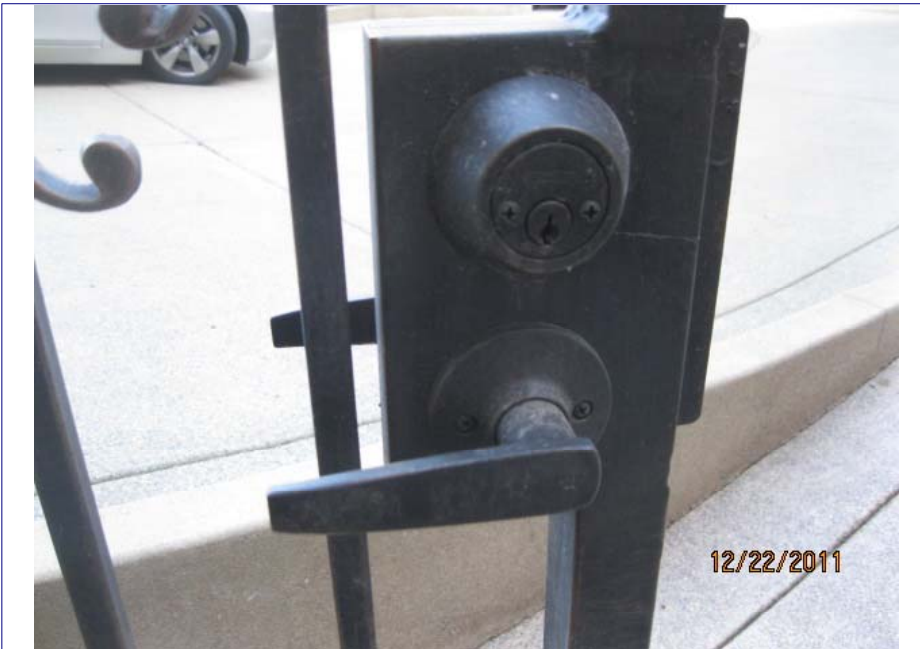
Picture 24

ALL KEYED LOCKS FROM INTERIOR TO EXTERIOR NEED TO BE LATCH TYPE FOR EMERGENCY EGRESS.(2,4)

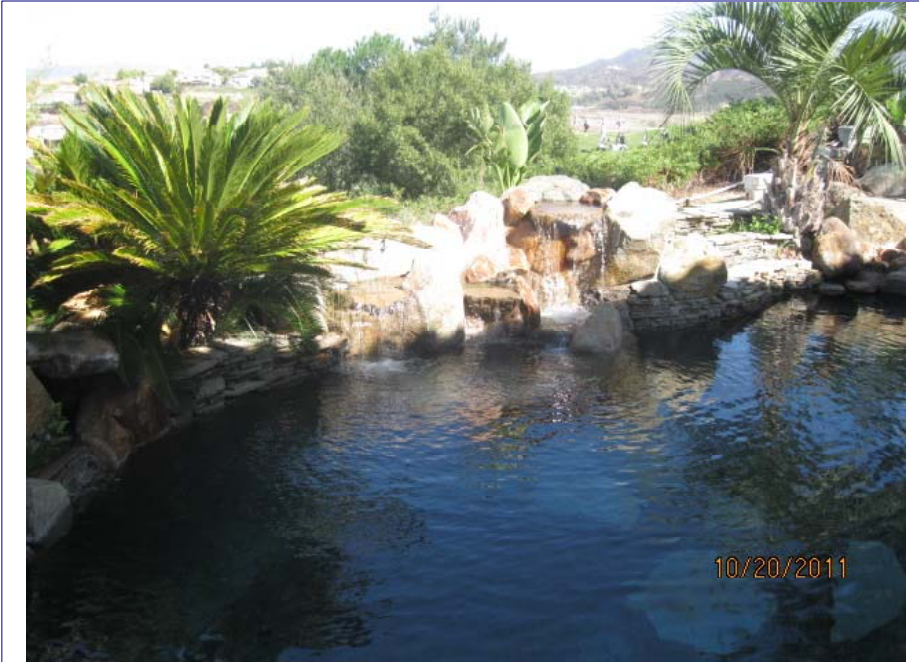
Picture 25

POOL WATERFALL HAD A LEAK AT THIS LOCATION, LEFT SIDE .(2)

POOL FENCE AND GATES WERE NOT INSTALLED AROUND POOL AT BACK YARD.(2,4)

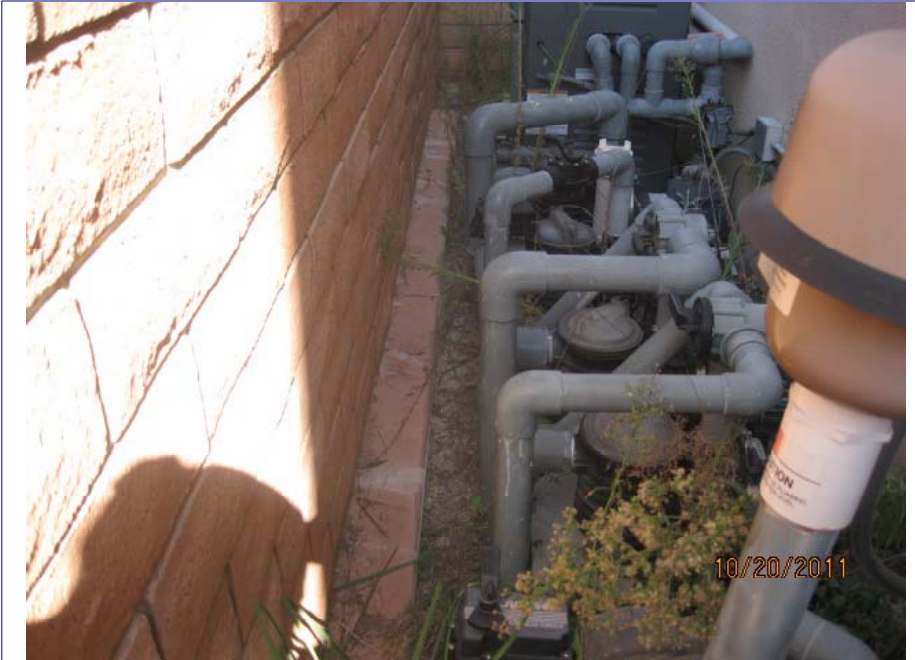
Picture 27

IMPROPER CLEARANCE TO POOL/SPA HEATER, DE FILTER AND ALL FIVE POOL PUMPS DUE TO THIS RETAINING WALL.(2)

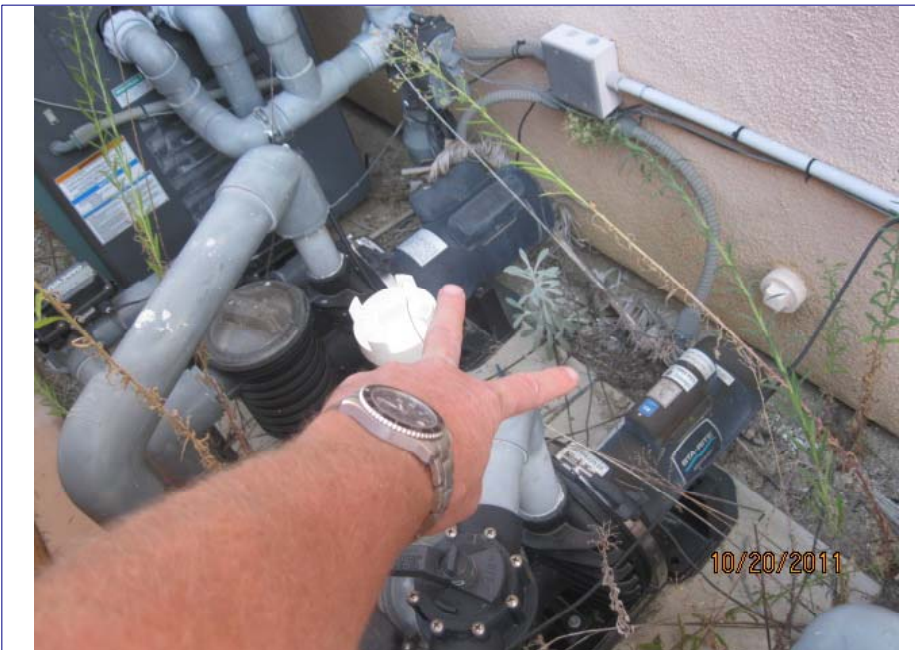
Picture 28

TWO POOL PUMPS MOTORS WERE NOT OPERATIONAL WHEN TESTED, BREAKERS WERE TURNED ON AND HAD POWER.(2)

THE ONE ON THE LEFT WAS FOR THE SPA JETS, THE ONE ON THE RIGHT WAS THE CIRCULATION PUMP.*
